Manhole Inspection Summary

Manhole # S31M1_007MH

Insp Date: **3/13/08 1:34 PM**

Location Address: **2500 Terra Firma Rd.**

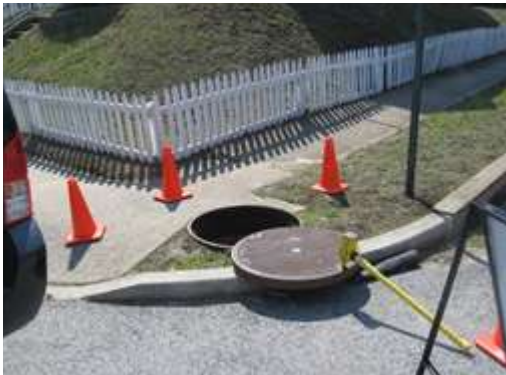
Location View

2500 Terra Firma Rd.

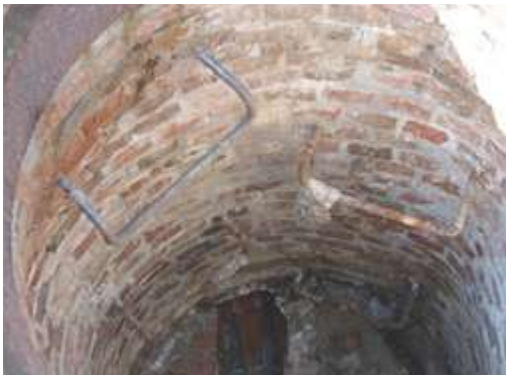
Steps Count: **4** Missing: **0** ☐ Corroded

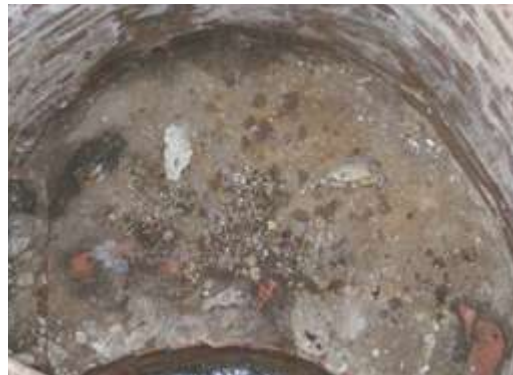
Defect 2

Bench

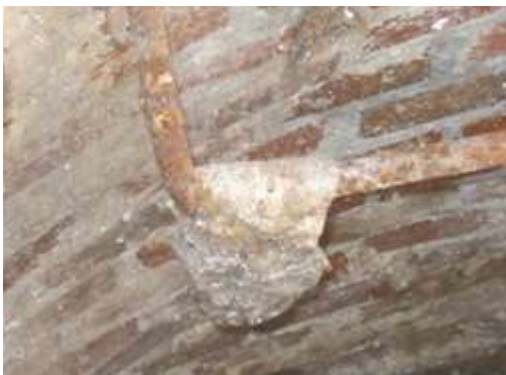
Defect 1

Step (trash)

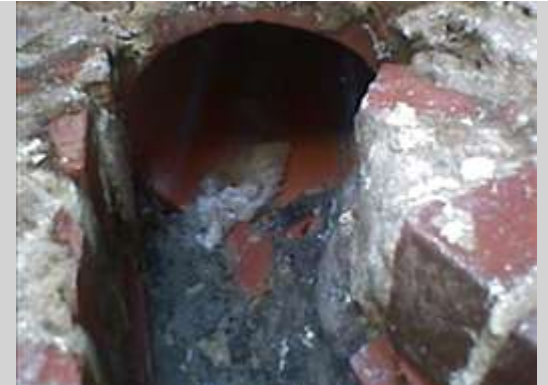
12 O'Clock Outflow

8 in. Circular Gravity Sewer
Pipe Out @ 12 O'Clock

Pipe Height: **8.4** (in.) Rod and Bar (Angled)
Pipe Material: **Clay** ☐ Pipe Lined
Invert Depth: **7.23** (ft.) Flow Characteristics: **Fast**
Deposits: ☒ None ☐ Mud ☐ Sludge ☐ Debris ☐ Grease
Silt Depth: (in.) Deposits Extent:
Infiltration: **None** Pipe Seal Cond: **Sound**

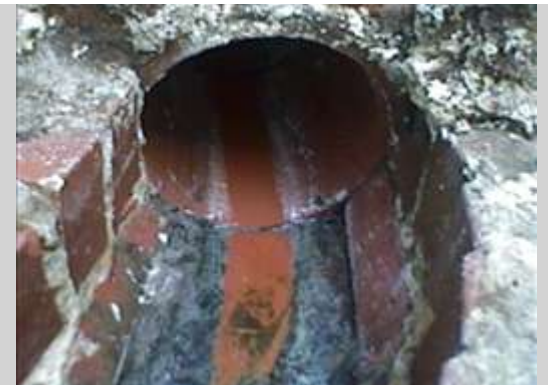
4 O'Clock Inflow

8 in. Circular Gravity Sewer
Pipe In @ 4 O'Clock

Pipe Height: **8.4** (in.) Rod and Bar (Angled)
Pipe Material: **Clay** ☐ Pipe Lined
Invert Depth: **7.09** (ft.) Flow Characteristics: **Fast**
Deposits: ☒ None ☐ Mud ☐ Sludge ☐ Debris ☐ Grease
Silt Depth: (in.) Deposits Extent:
Infiltration: **None** Pipe Seal Cond: **Sound**
